1. Project Name: Agat SBH
2. Date of Inspection: June 7, 2002
3. Inspection Personnel:

The overall condition of the project is good.

MAIN BREAKWATER - 985 LF:

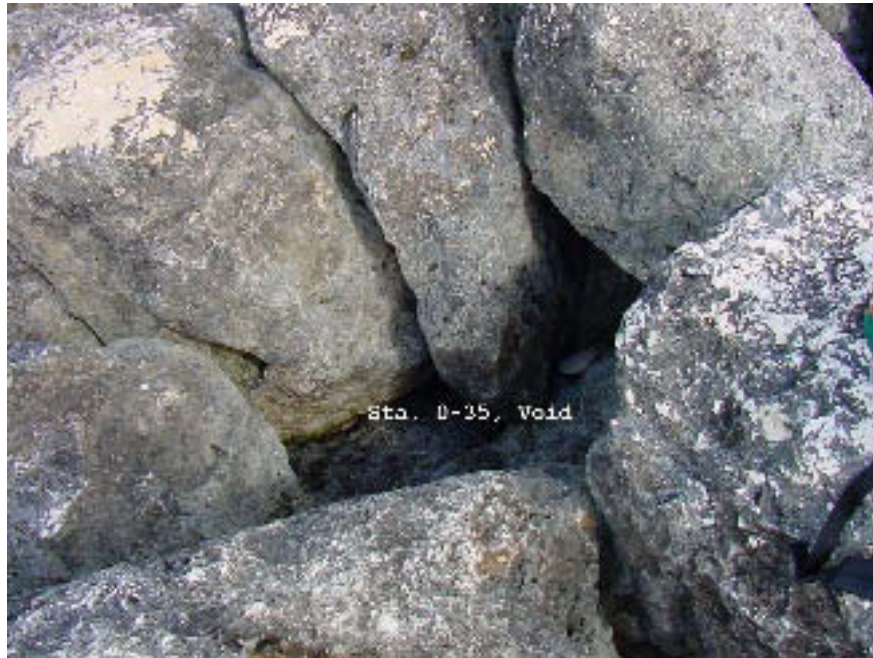
- a. Sta. 0-35, Crest/Sideslope, Void, the missing armor stones appear to be resting on the OS of the structure.

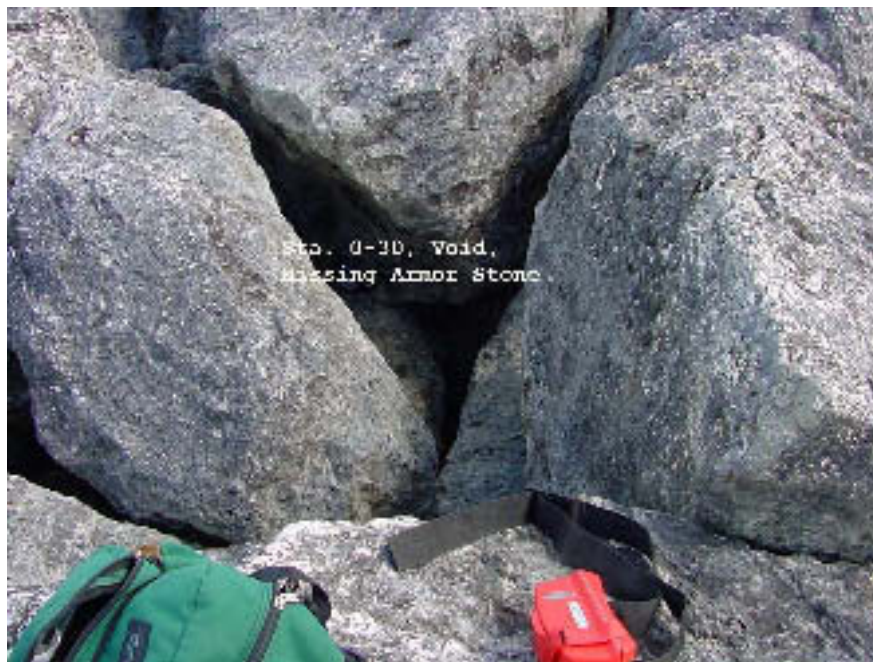
- b. Sta. 0-30, Crest/Sideslope, Void, the missing armor stones appear to be resting on the OS of the structure.

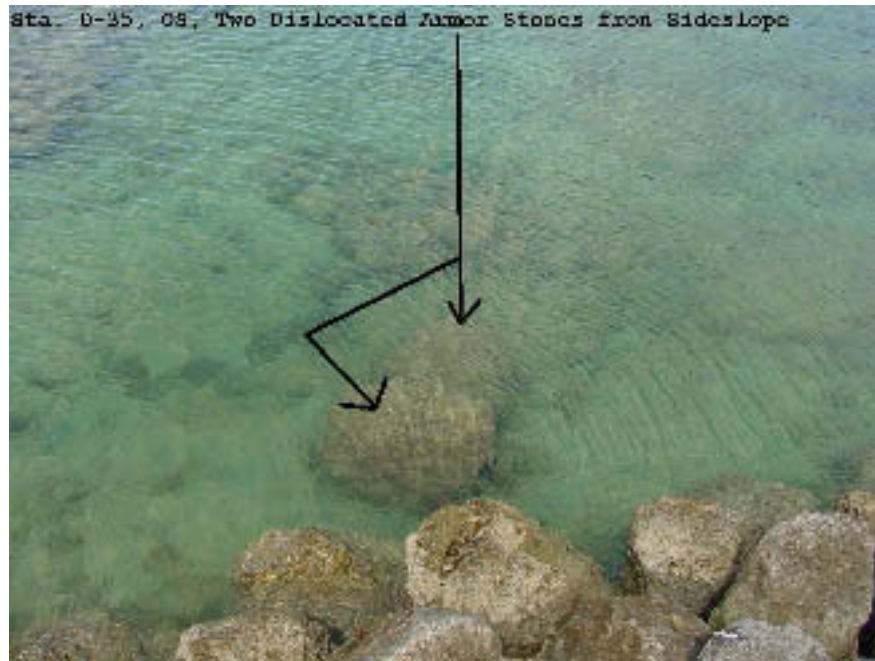
c. Sta. 0-35, 2 ea. armor stones (AS) are resting adjacent the structure. These AS may be from the above identified voids.

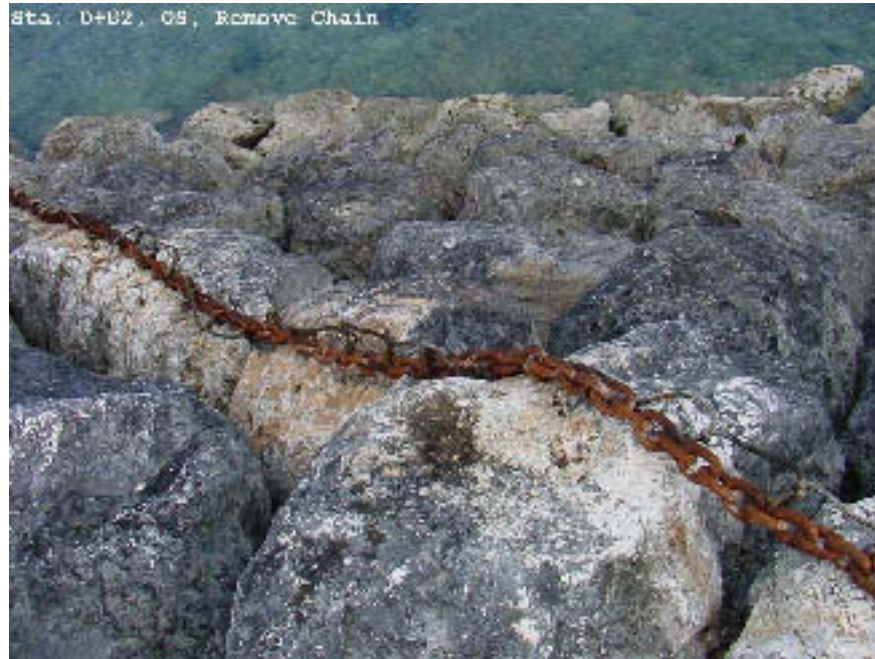
e. Sta. 0+82, OS, Remove chain.

Vegetation removal from the structures should be accomplished before conditions worsen. The chains that are installed by persons unknown, on the main breakwater needs to be removed. These are used for temporary mooring during storms and have not been designed into the project.

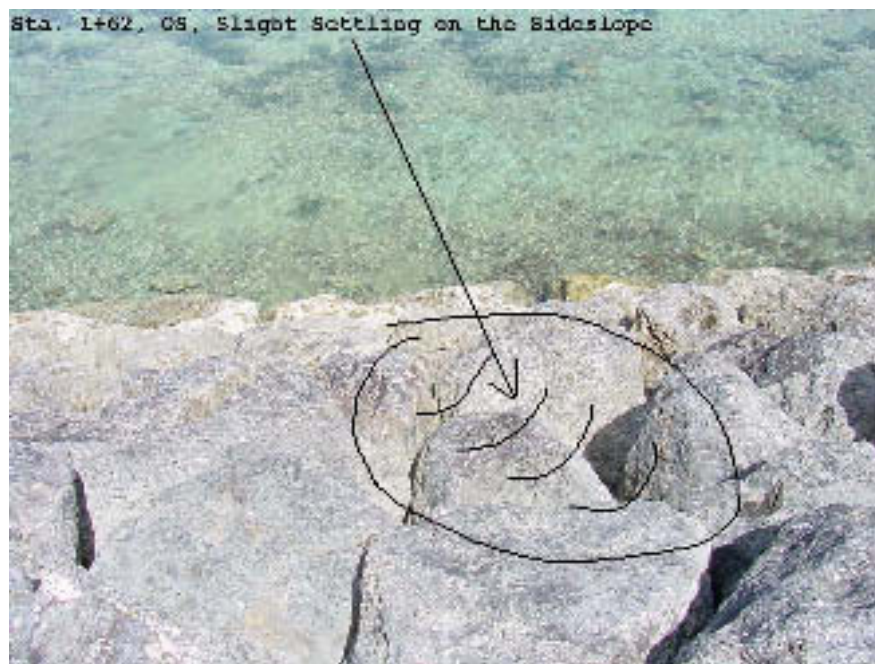
f. Sta. 1+62, OS, Monitor slight settling on the sideslope.

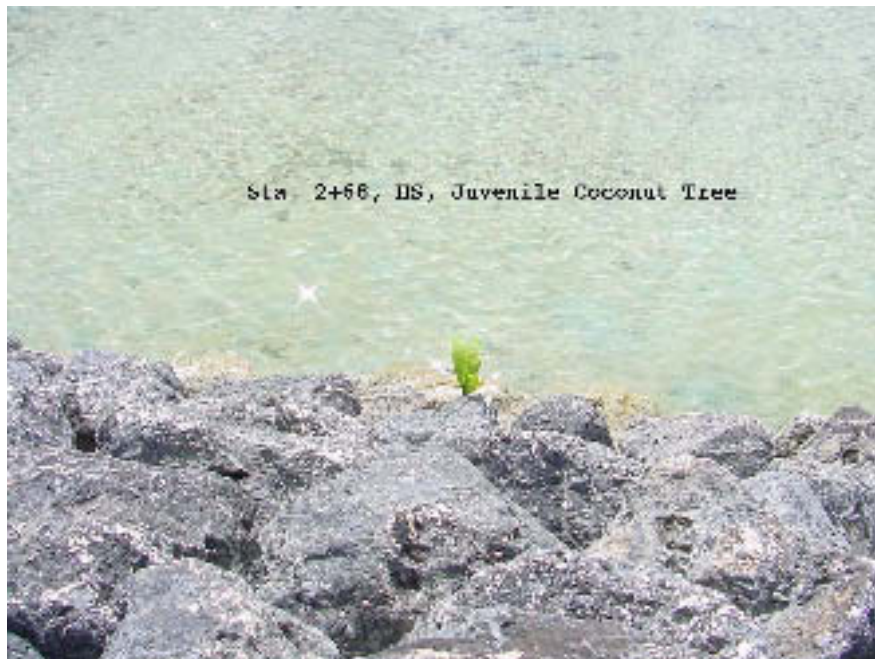
h. Sta. 2+68, HS, Remove juvenile coconut tree.

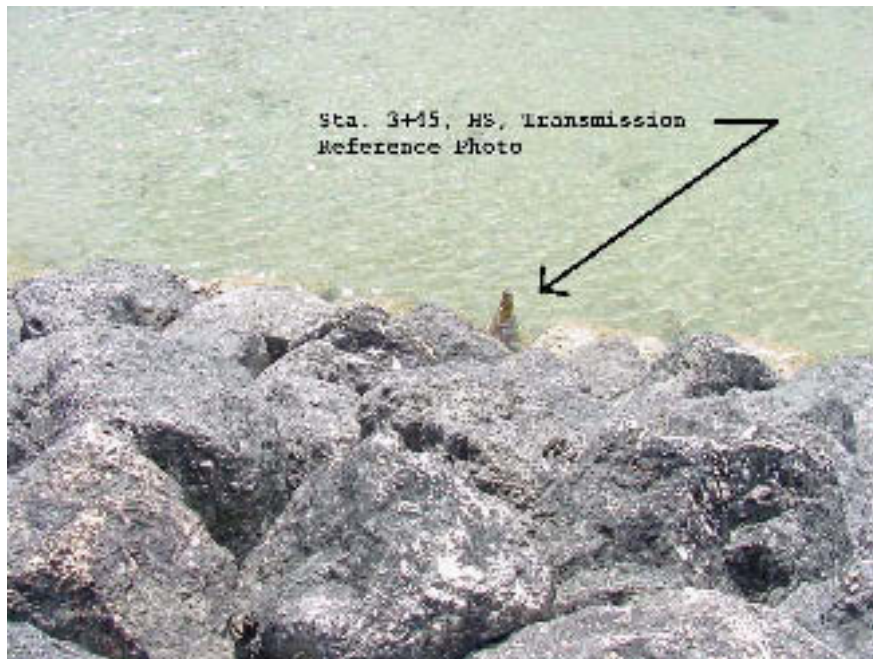
j. Sta. 3+45, Remove auto transmission (reference photo).

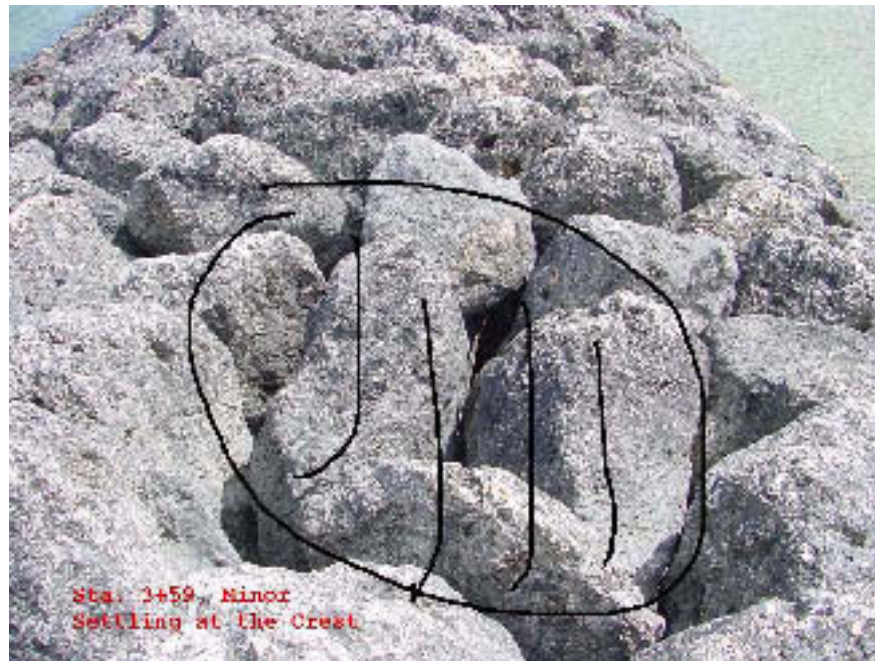
- k. Sta. 3+59, CL, Monitor minor settling.

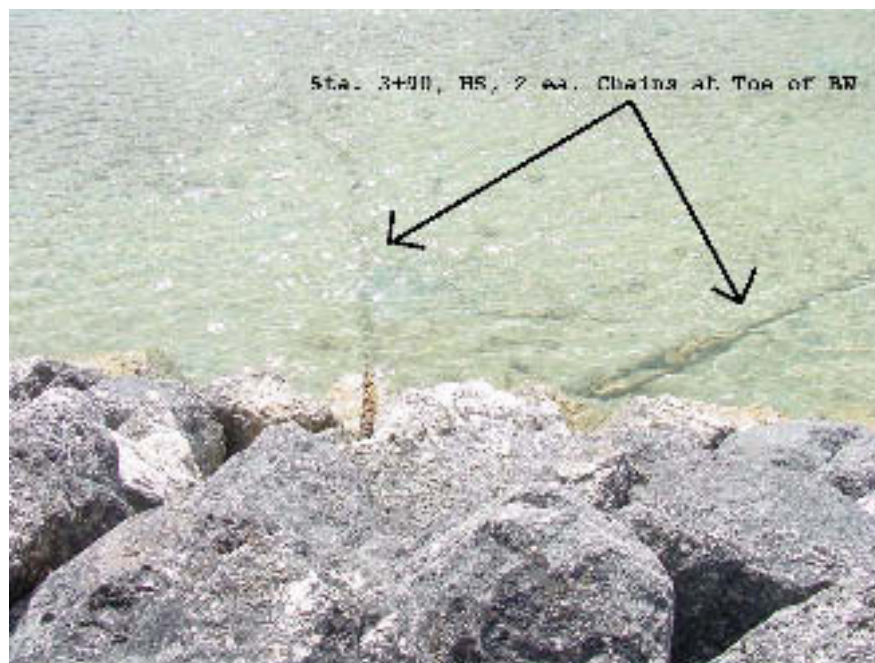
- l. Sta. 3+90, HS, Remove chains.

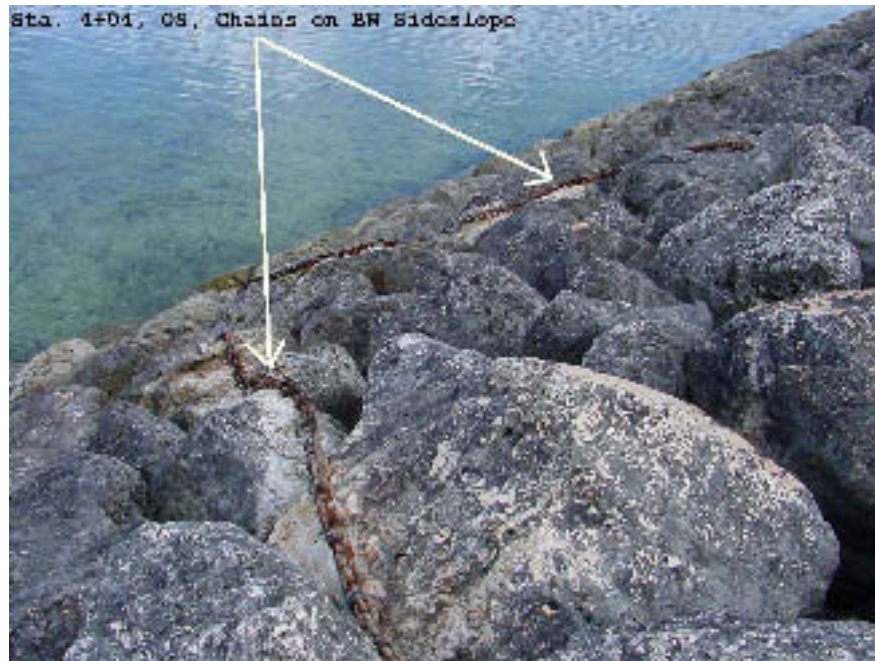
m. Sta. 4+04, OS, Remove chains.

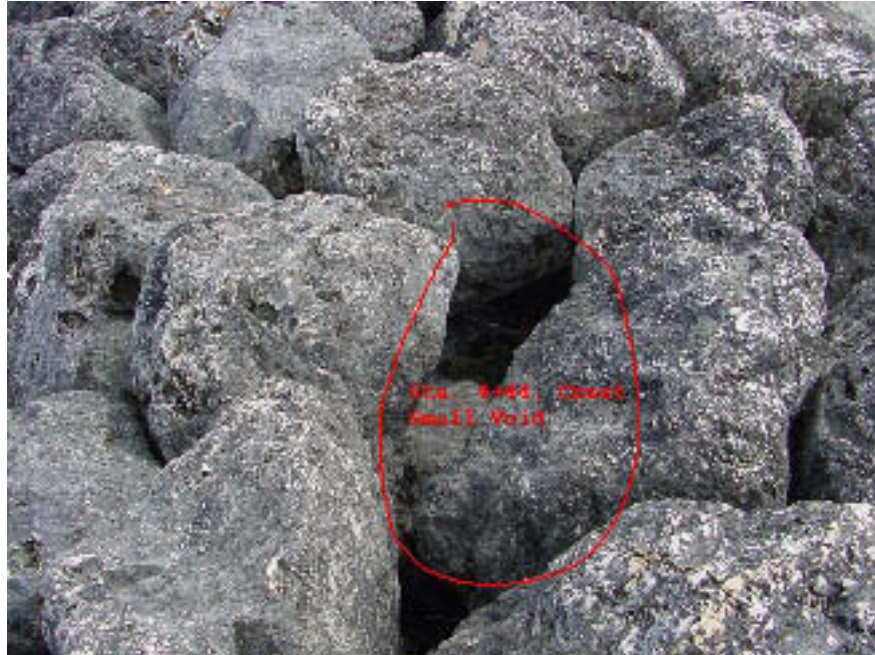
n. Sta. 4+44, CL, Monitor small void, no obvious settling.

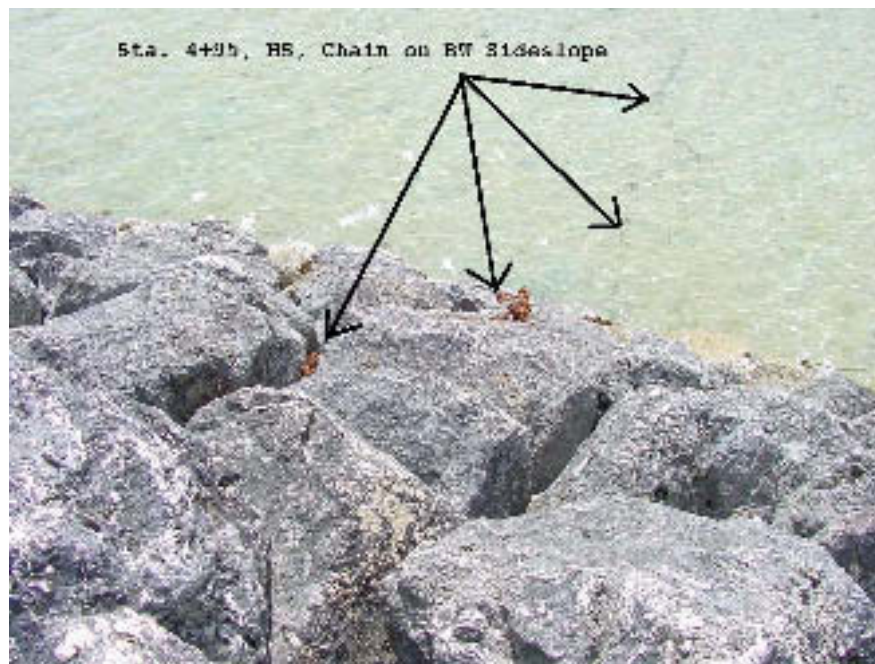
- o. Sta. 4+95, HS, Remove chains.

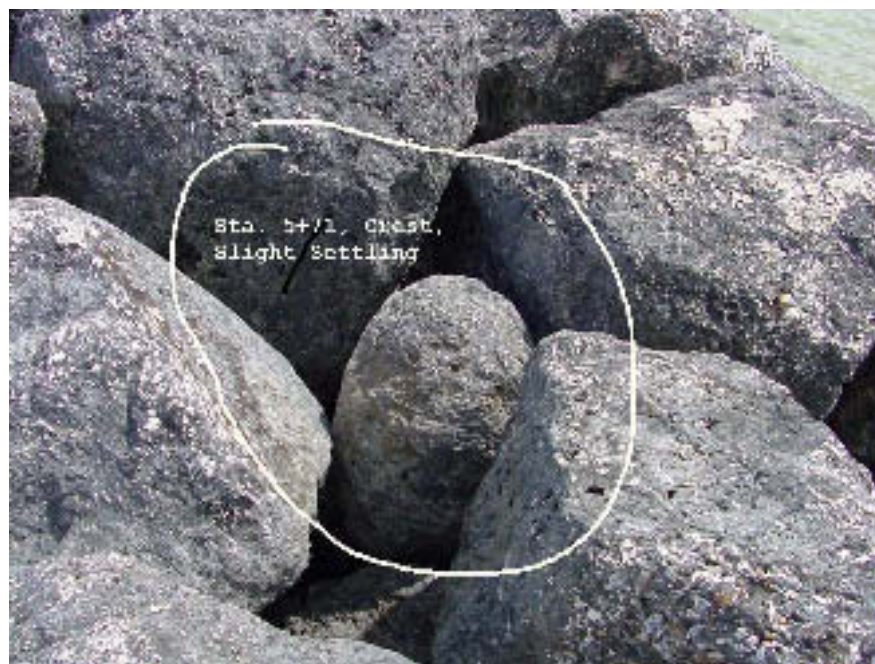
- p. Sta. 5+71, CL, Monitor slight settling.

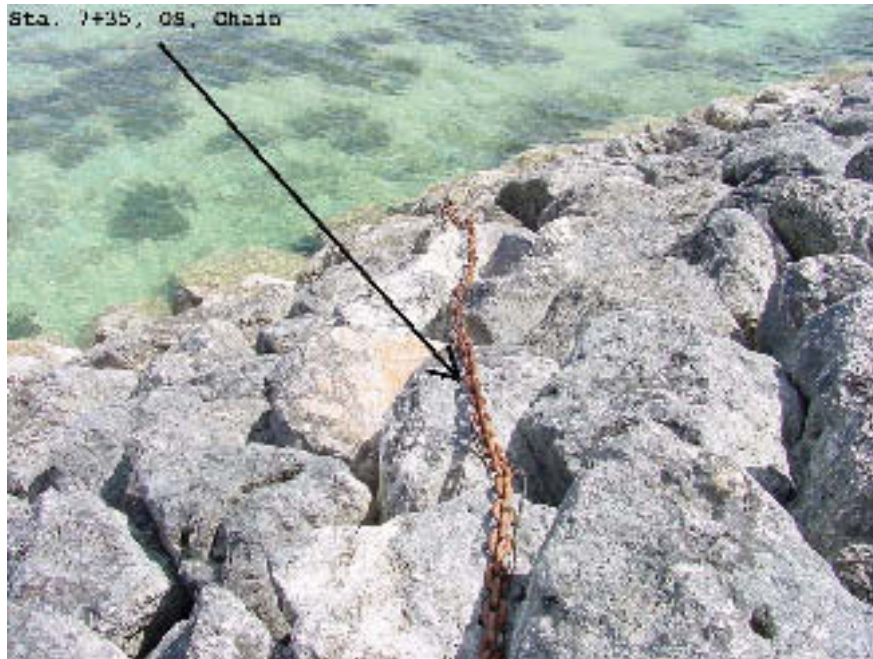
r. Sta. 7+35, OS, Remove chain.

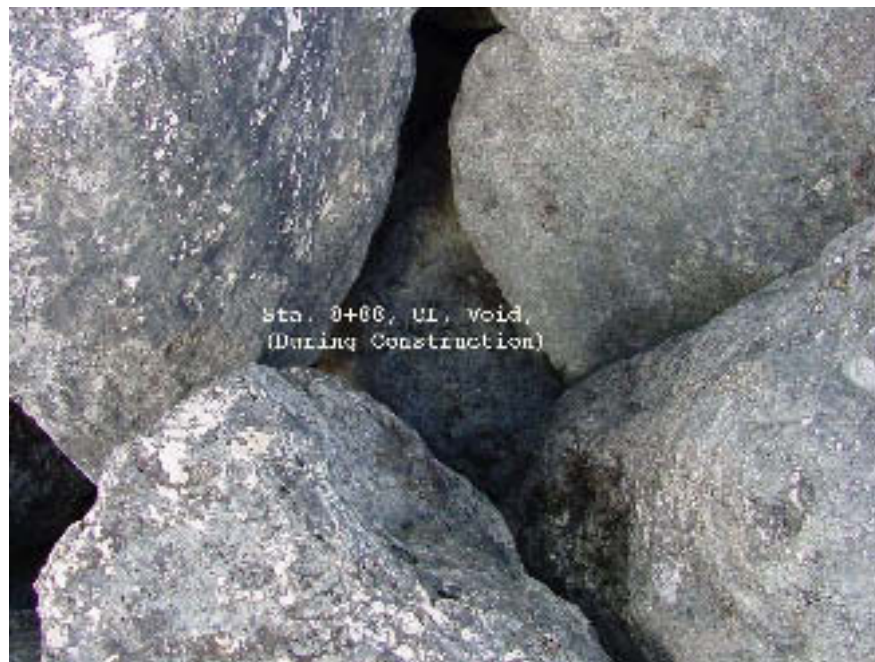
t. Sta. 8+88, CL, Monitor void area.

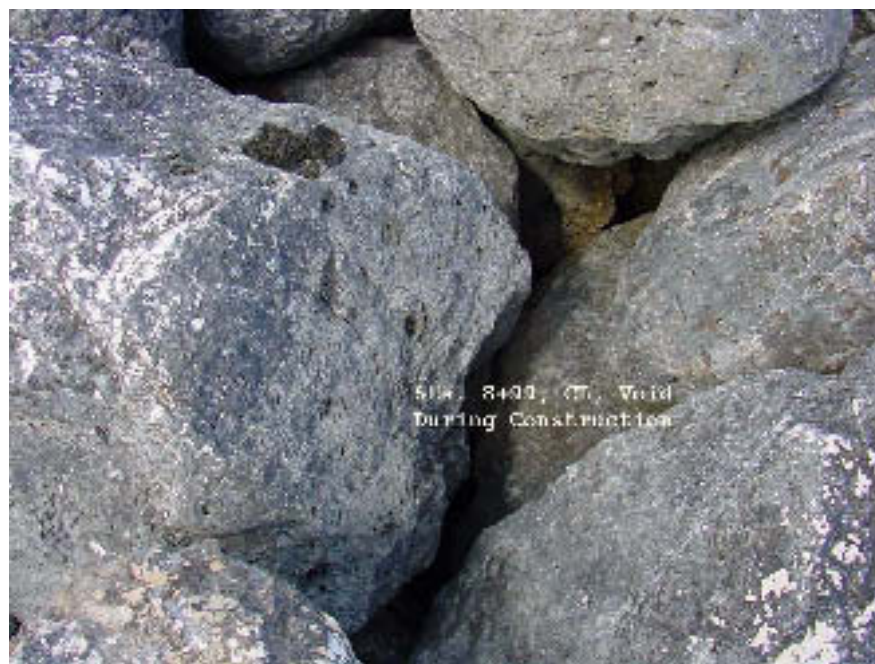
v. Sta. 8+99, CL, Monitor void area.

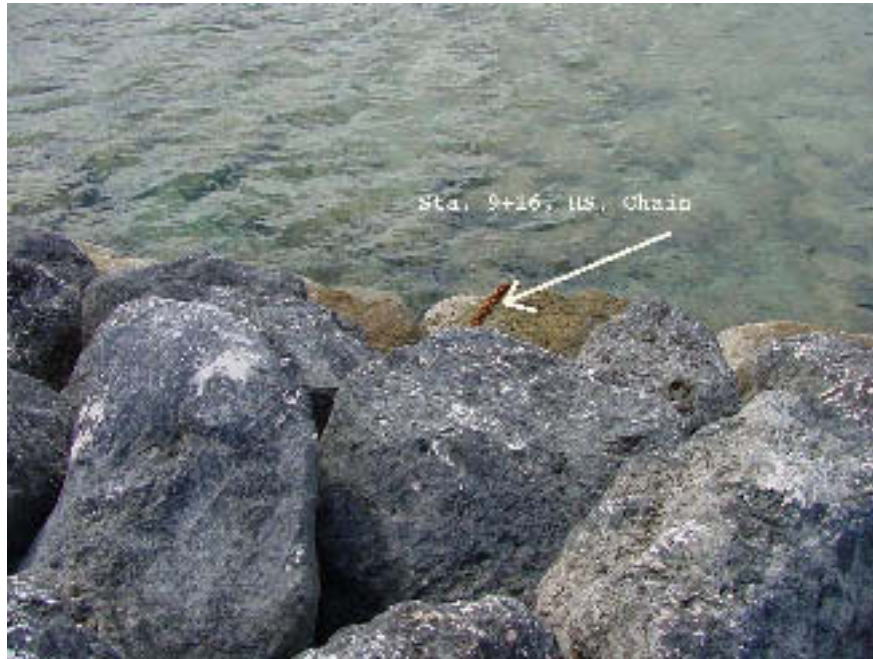
w. Sta. 9+16, HS, Remove chain.

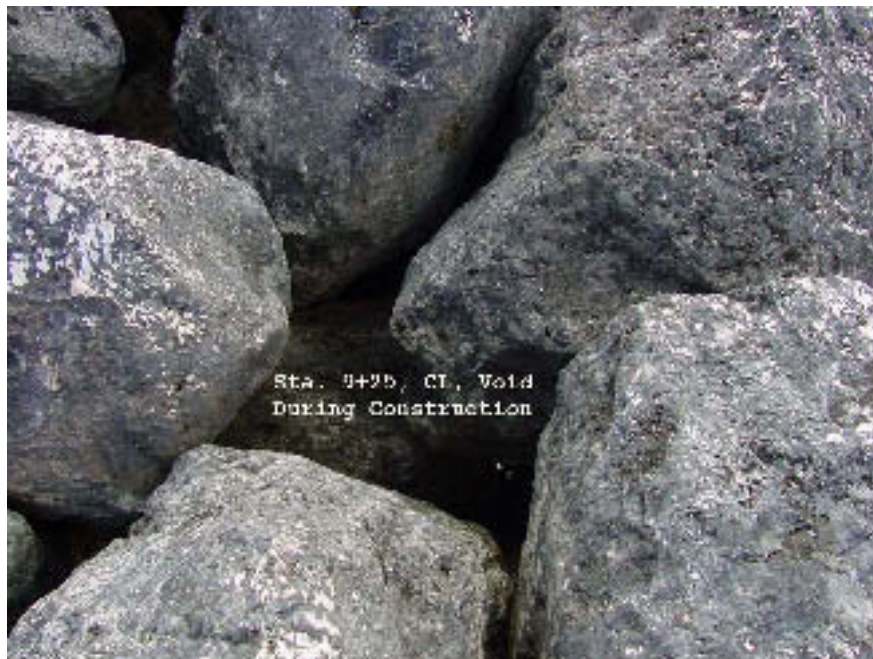
x. Sta. 9+25, CL, Monitor void area.

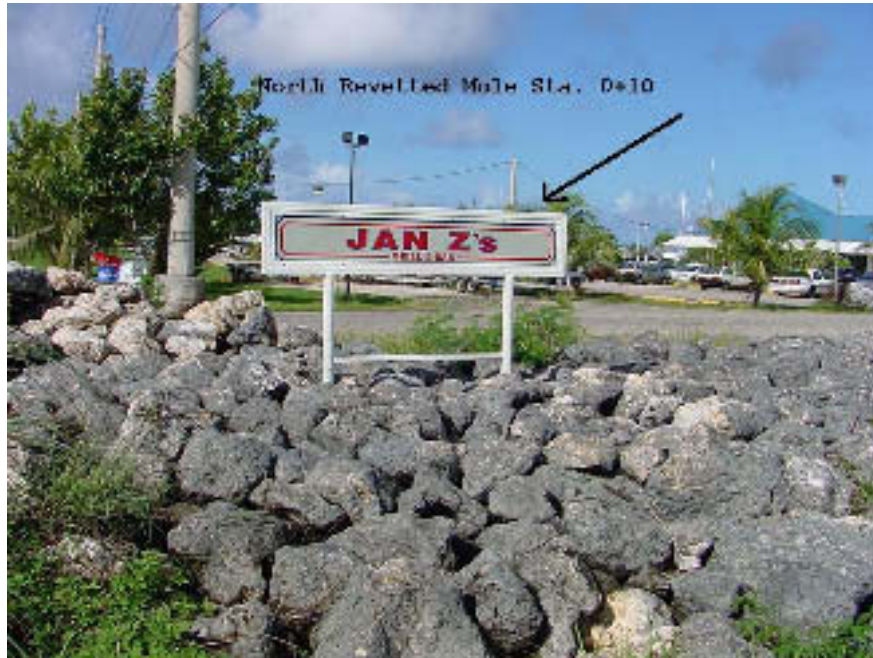
The North Revetted Mole, 300 LF, has a minor encroachment, which is the installation of a business sign at the crest. I spoke with Mr. Bill Bradford, Manager of JanZs Seafood Restaurant, Agat Marina and explained the structures ownership. Bradford stated the sign had been there for 8 years however, he would remove it. Other deficiencies are toe armor stone movement and vegetation.

- a. Sta. 0+10, CL, Unauthorized encroachment, remove sign.

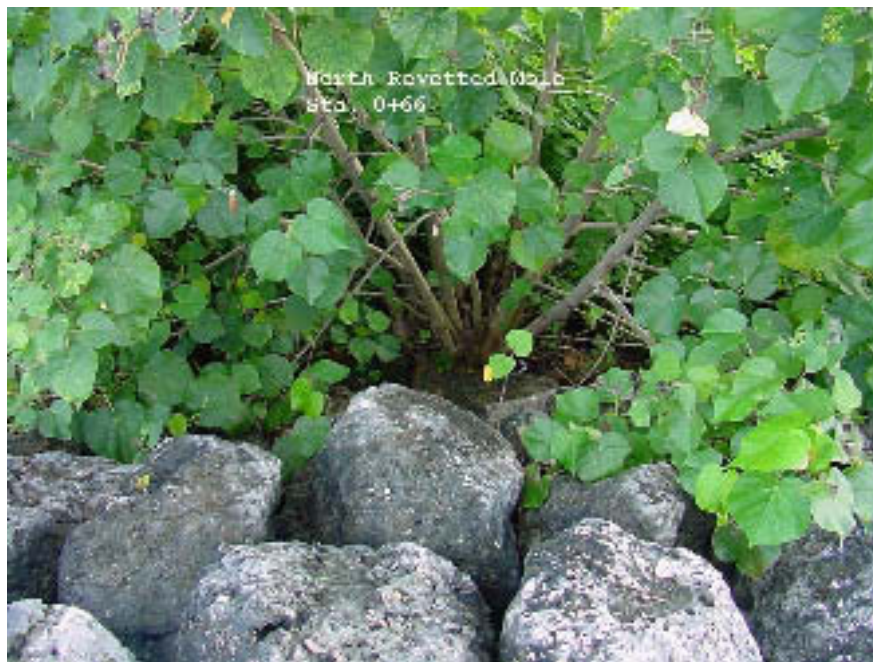
- b. Sta. 0+66, OS, Remove tree.

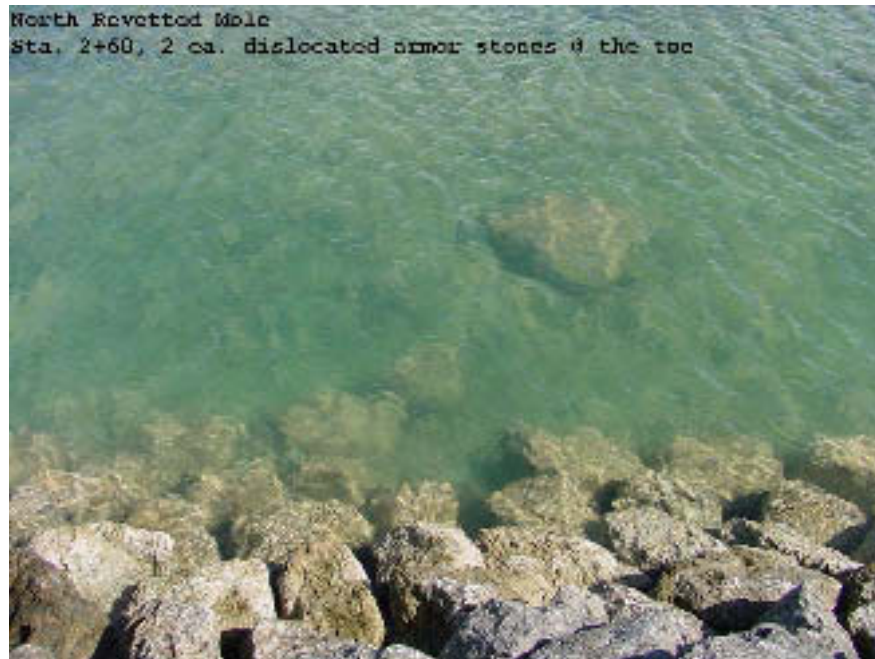
d. Sta. 2+68, OS, Monitor the toe of the structure and dislocated armor stones at this area. This area at the intersection of the berthing area dredge cut and the reef flat has "scoured" a small channel.

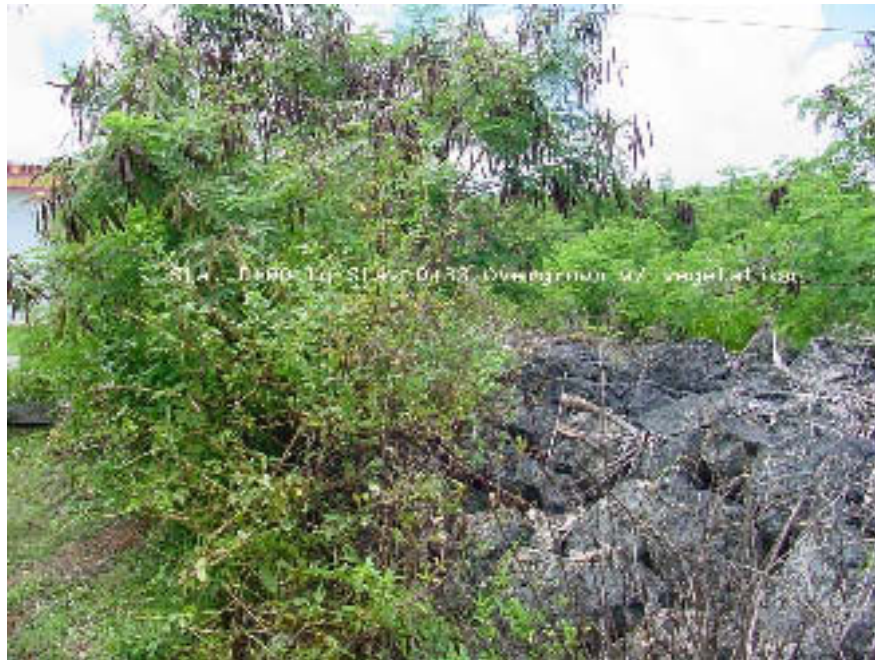
- a. Sta. 0+00 to Sta. 0+33, HS, Remove vegetation.

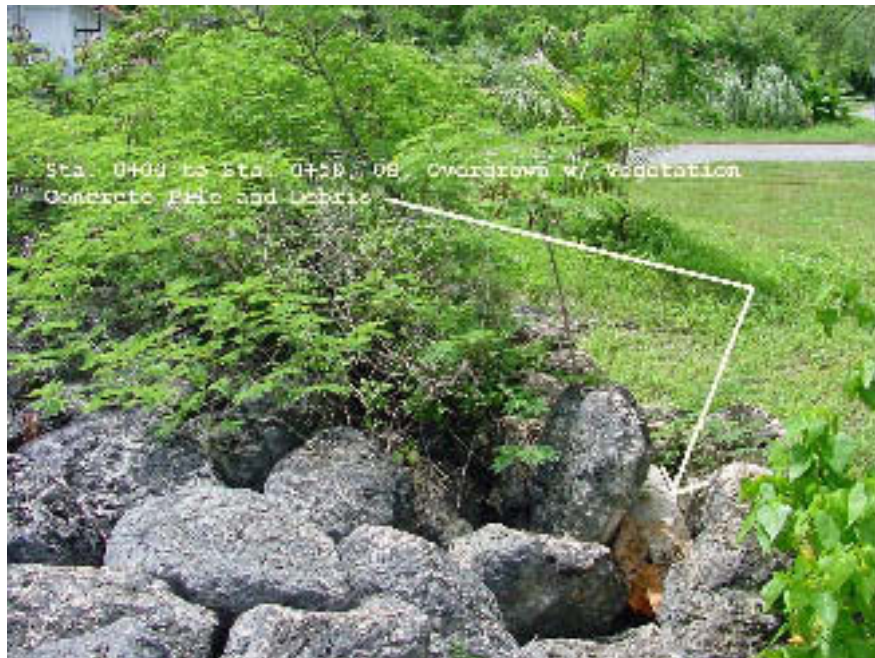
- b. Sta. 0+00 to Sta. 0+50, OS, Remove vegetation.

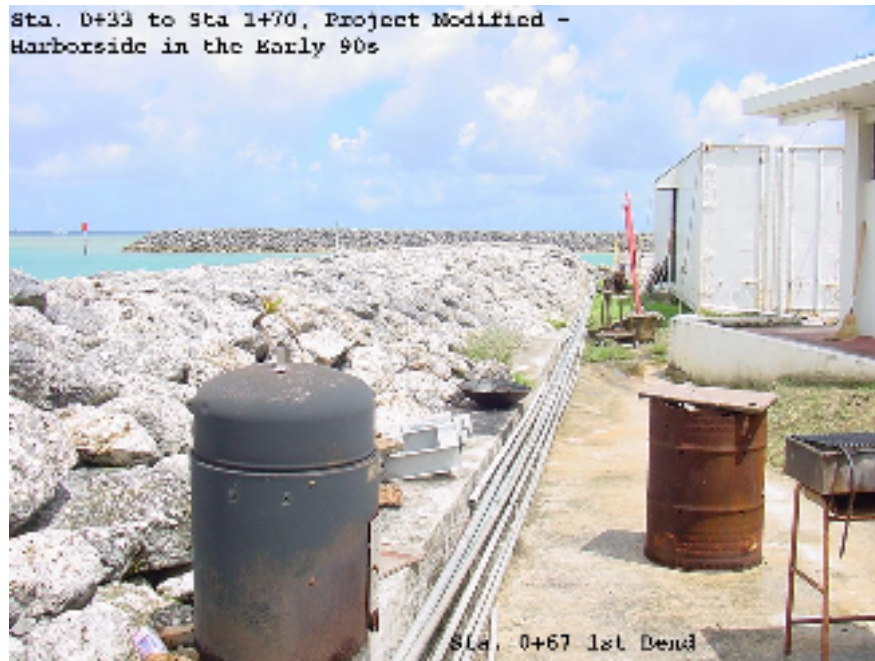
The South Revetted Mole, 180 LF, was modified in the early 1990s. DPW or Ports may have done this modification. There are no updated AS-BUILT drawings for this work. The structure has well-established vegetation at the root section as the primary deficiency.

c. Sta. 0+33 to Sta. 1+70, HS, Structure modified.

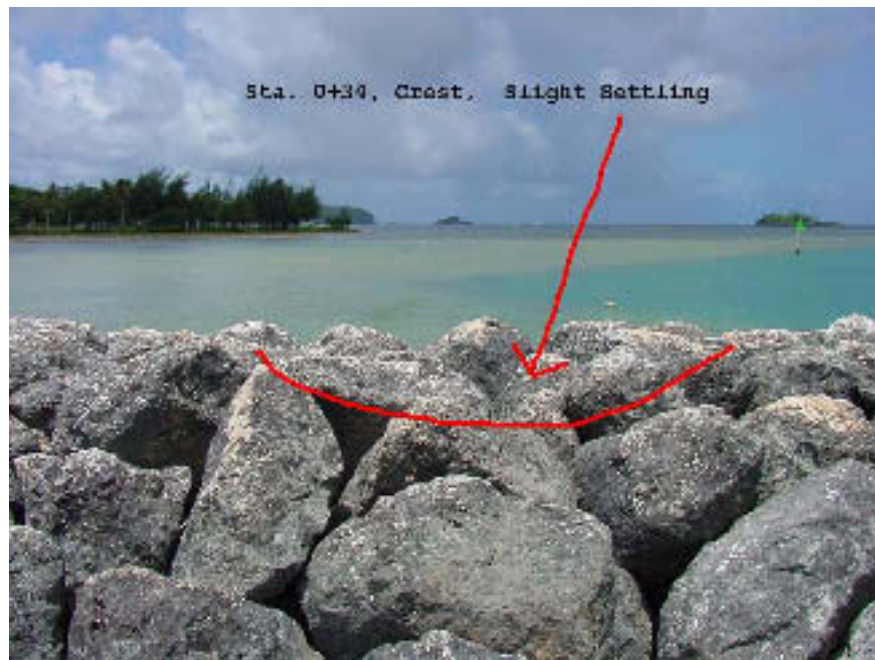
b. Sta. 0+34, CL, Monitor slight settling.
